**DEPARTMENT OF TRANSPORTATION****DIVISION OF ENGINEERING SERVICES**

Contract #: 04-0120F4Cty: SF/ALA Rte: 80 PM: 13.2/13.9File #: 69.28**WELDING INSPECTION REPORT****Resident Engineer:**Pursell, Gary**Address:** 333 Burma Road**City:** Oakland, CA 94607**Report No:** WIR-000606**Date Inspected:** 06-Oct-2007**Project Name:** SAS Superstructure**OSM Arrival Time:** 630**Prime Contractor:** American Bridge/Fluor Enterprises, a JV**OSM Departure Time:** 1530**Contractor:** Zhenhua Port Machinery Company, Ltd (ZPMC), Changxing Island **Location:** Shanghai, China**CWI Name:** Xu Bing**CWI Present:** Yes No**Inspected CWI report:** Yes No N/A**Rod Oven in Use:** Yes No N/A**Electrode to specification:** Yes No N/A**Weld Procedures Followed:** Yes No N/A**Qualified Welders:** Yes No N/A**Verified Joint Fit-up:** Yes No N/A**Approved Drawings:** Yes No N/A**Approved WPS:** Yes No N/A**Delayed / Cancelled:** Yes No N/A**Bridge No:** 34-0006**Component:** N/A**Summary of Items Observed:**

CALTRANS Quality Assurance (QA) Inspector, Alfredo Acuna was present for the fabrication of the Mock-up 77, 89 and 114 meters elevations scheduled for this project at the ZPMC facility in Shanghai, Chin

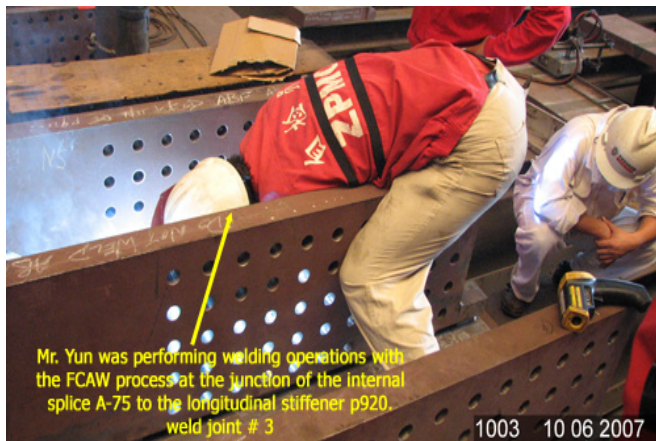
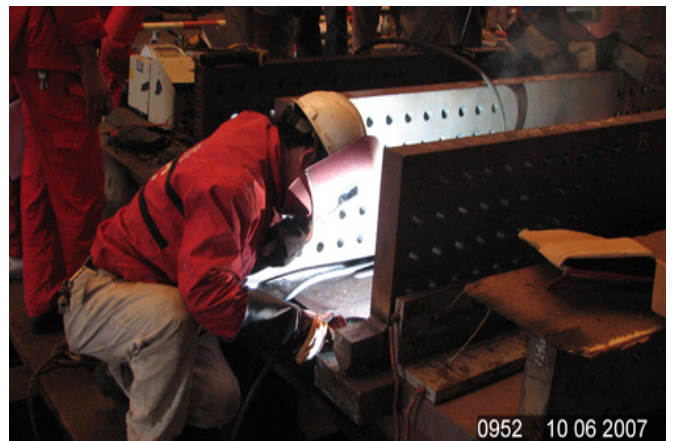
Item	Description	WBS	Dwg No.	Status
1	Tower Splice Mock-up 114 M weld joint # 3 longitudinal stiffener to A75 internal splice plate			
	ZPMC, welders Yun Jun Xian was observed by the QA Inspector performing welding operations on the internal splice panel A75. Mr. Zhan was observed welding the filler passes at the junction of the mp1 to skin panel A, joint #

1 following the approved welding procedure specification WPS-B-T-2332-TC-U5-F. Base metal was designated as A-709 Grade 50. ZPMC was using the flux cored arc welding (FCAW) process in the horizontal (2G) position with the 1.4 mm diameter electrode designated as E71T-1 /AWS A5.20, brand name Supercored. The QA Inspector verified amperage, voltage, travel speed, preheat and heat interpass temperatures for the filler passes. The QA inspector found that the welding parameters recorded after ZPMC approved Certified Welder Inspector Xu Bing appeared to be in accordance with the contract documents.

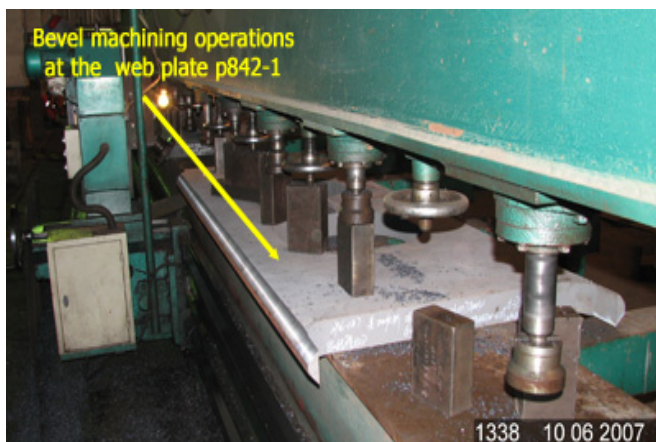
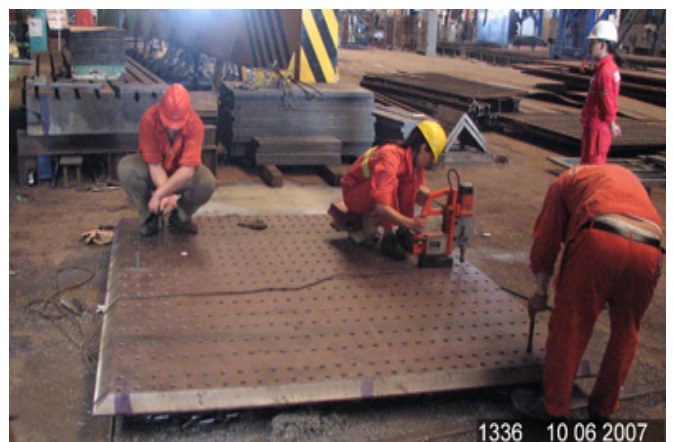
## 2 Machining and drilling operations

The QA inspector observed ZPMC personnel performing machining operations at the bevel preparations for the web plate p842-1 Tower Mock-up 89 meter elevation and the drilling operations on the splice plates for the Tower splice Mock-up 114 meter elevation. The photographs below show the machining and drilling operations in process.
